# Manhole Inspection Summary

Manhole # S03CC2066MH

**Location** Address: **6208 CROSS COUNTRY BLVD** Cross Street: **PINKNEY ST**

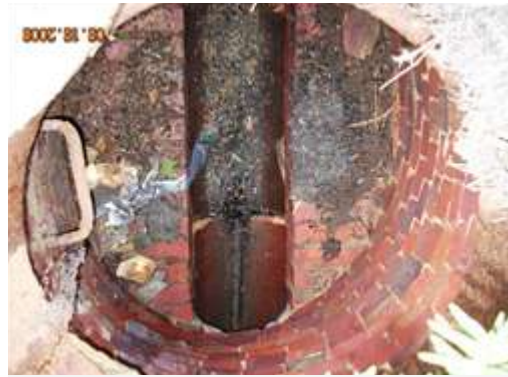
Top View

Corroded steps. Evidence of surcharge - Bench debris. Channel crack and debris.

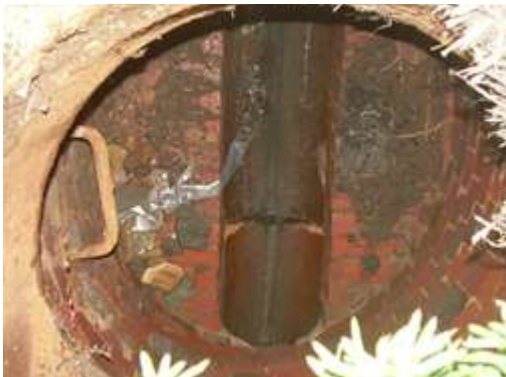
Top View

Corroded steps. Evidence of surcharge - Bench debris. Channel debris. Channel crack.

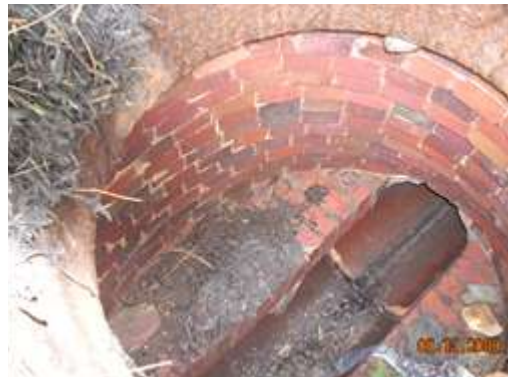
Defect

**Corbel** Material: **Brick** ☐ Parged Type: **Concentric/Eccentric**  
Condition: ☐ Sound ☐ Cracked ☒ **Root Intrusion** ☐ Loose Brick ☒ **Deteriorated**  
Infiltration: ☐ None ☒ **Joint** ☐ Cracks ☐ Mortar ☒ **Roots** ☒ **Wall**

**Barrel** Material: **Brick** ☐ Parged  
Shape: **Circular** Diameter: **46** (in.) Length: (in.)  
Condition: ☒ Sound ☐ Cracked ☐ Root Intrusion ☐ Loose Brick ☐ Deteriorated  
Infiltration: ☐ None ☐ Joint ☐ Cracks ☐ Mortar ☐ Roots ☒ **Wall**

Corbel deterioration and infiltration. Barrel infiltration.

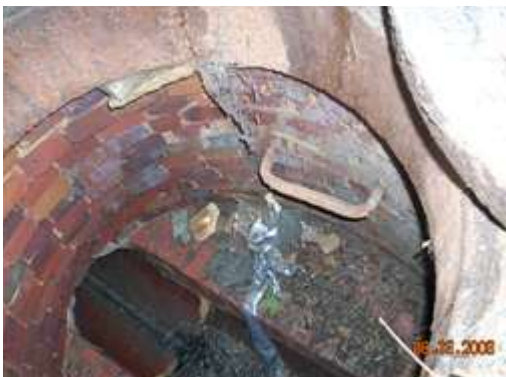
Defect

Corbel root intrusion and infiltration.

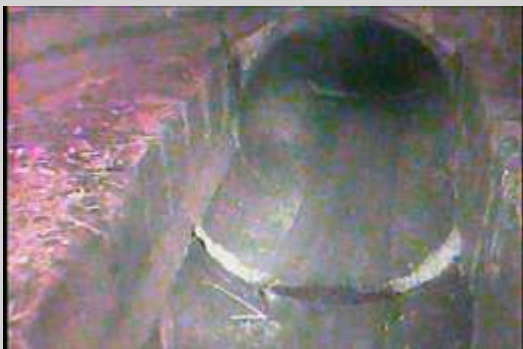
### 10 in. Circular Gravity Sewer Pipe In @ 6 O'Clock

Infiltration: **Evidence** Pipe Seal Cond: **Unknown**
